# Manhole Inspection Summary

Manhole # S27E\_\_047MH

Insp Date: 1/15/09 11:28 AM

**Location** Address: **104 Vine St.**

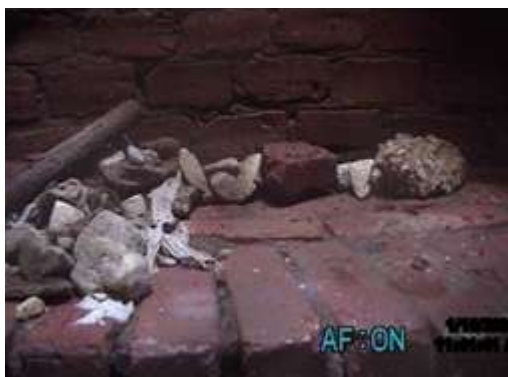
Misc

Condition: ☒ Sound ☐ Cracked ☐ Root Intrusion ☐ Deteriorated ☐ Leaks ☐ Debris

debris on the bench

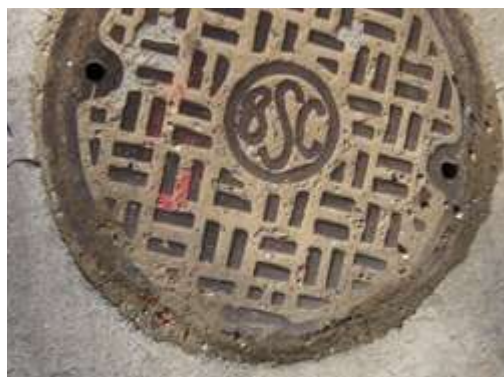
Misc

Type: **Sanitary** Condition: **Sound** Cover Material: **Cast Iron**

cover

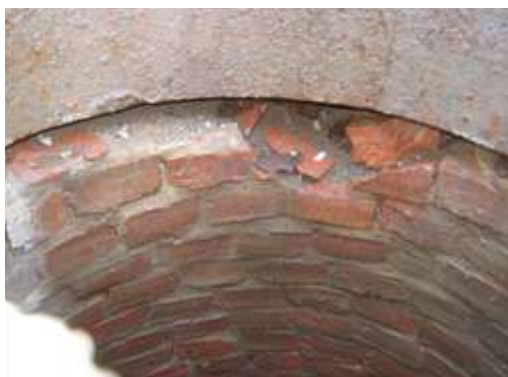
Defect 2

Condition: ☐ Sound ☐ Cracked ☐ Root Intrusion ☐ Loose Brick ☒ **Deteriorated**

Infiltration: ☐ None ☒ **Joint** ☐ Cracks ☐ Mortar ☐ Roots ☐ Wall

chimney deteriorated and infiltration at frame joint

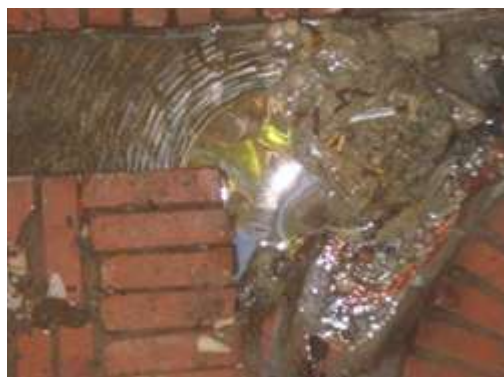
Defect 3

Condition: ☐ Sound ☐ Cracked ☐ Root Intrusion ☐ Deteriorated ☐ Leaks ☒ **Debris**

channel debris

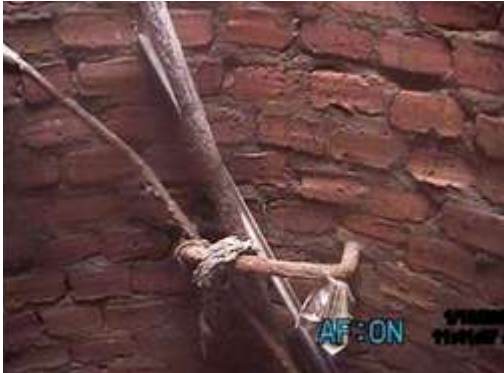
### Defect 1

**Steps** Count: **6** Missing: **0** ☒ **Corroded**

**Surcharge** ☒ **Evidence Of Surcharge** Depth: **1** (ft.) ☐ Active Surcharge Present

steps corroded, surcharge evidence 1 foot

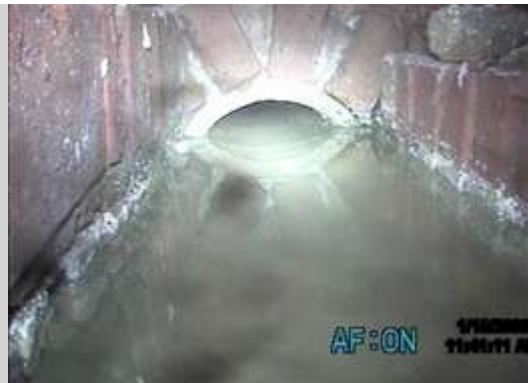
6 O'Clock Inflow

Deposits: ☐ None ☐ Mud ☒ **Sludge** ☐ Debris ☐ Grease

Silt Depth: **3** (in.) Deposits Extent: **Medium**
